HV Switchboard Maintenance for LNG/C

Specialized Service for LNG Ships

1. Introduction

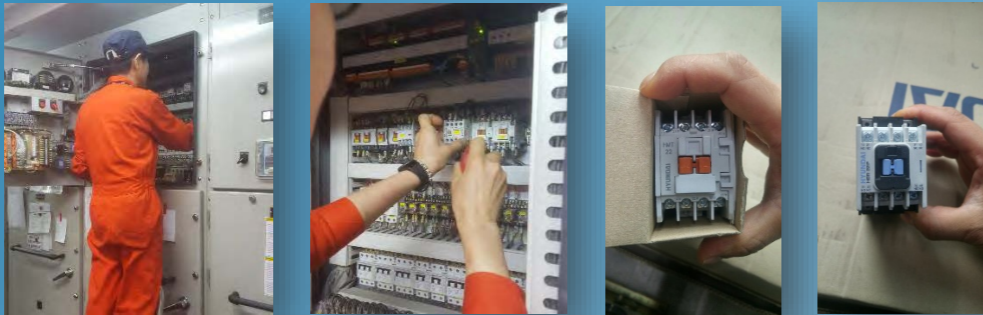
1) Aux. Relay replacement

Considering life time 7~8 year, to replace the aux. relay in major panel at every 5 years dry dock would be most economical way to avoid unexpected accident.

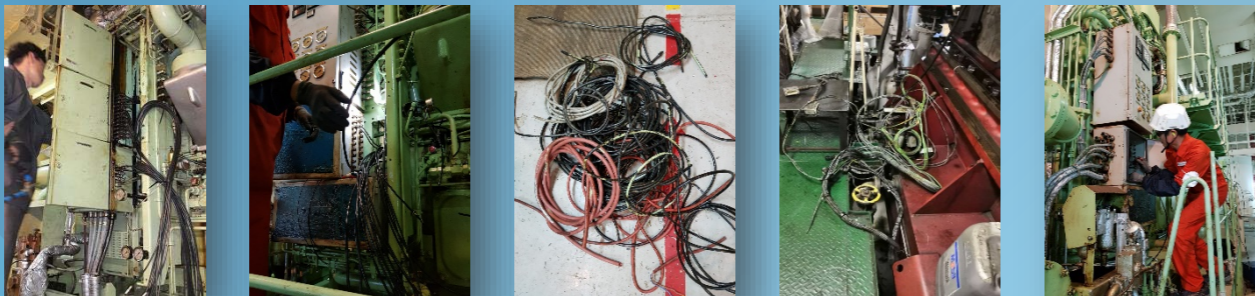
2) DG Control cable replacement

We have previous experiences that there was deterioration of generator engine cable. Some D/G cables were already started deterioration as below photos. We replaced new cable and it was confirmed by ship's staff.

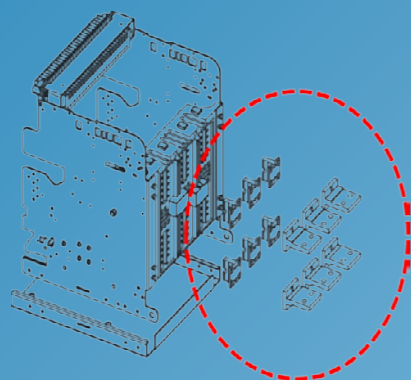
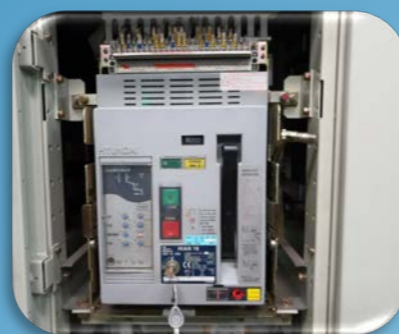
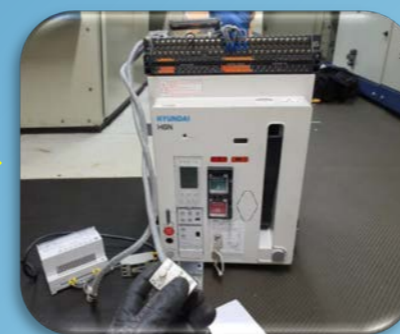
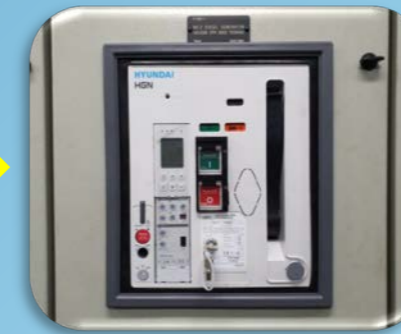
1) Old ACB(HiAN) retrofit to New type(HGN)

KGS has launched new retrofit service of HiAN to HGN type, without changing bus-bars within a day. This retrofit service extends to other maker's ACB, such as ABB, Terasaki & Schneider.

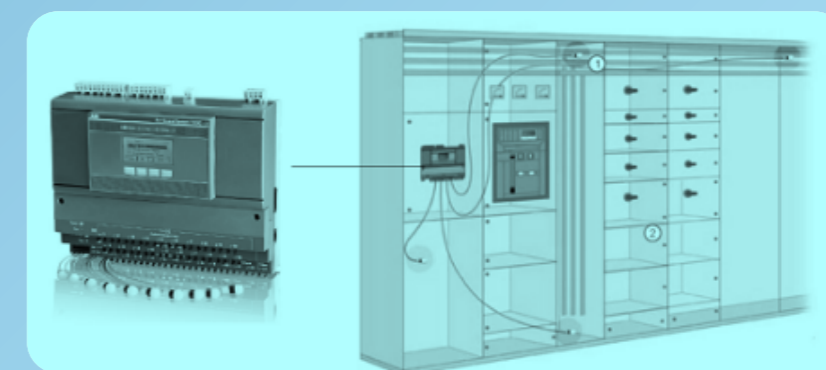
2) Arc Flash Protection Retrofit

KGS conducted retrofit project of Arc Flash Protection for LV Switchboard LNG vessels. By technical cooperation with ABB, KGS has completed project 8 vessels successfully. This retrofit prevents any possible fire accident derived from arc flash inside panel.

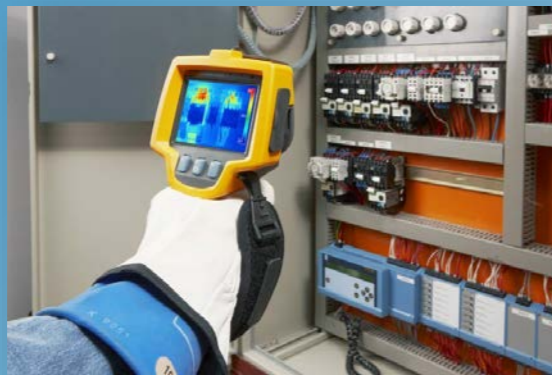
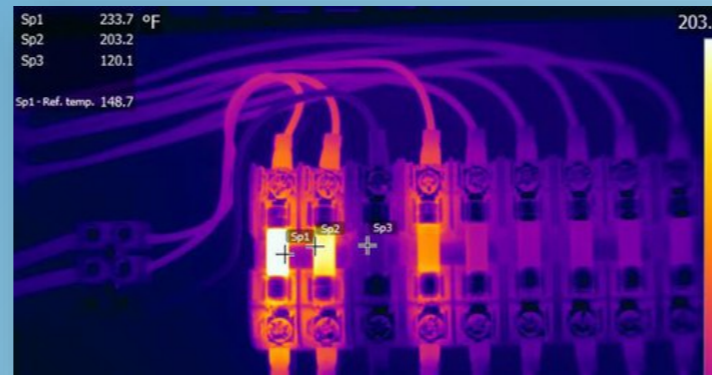
4) SWBD Thermography Inspection

KGS engineer has trained by FLIR official program and can provide special inspection for maintenance. Thermographic inspections are conducted while the electrical system is on load. (Rate: \$1,100/day)

SERVICE REPORT		FORM NO.	
THERMOGRAPHIC SURVEY		KGS-E-30	
Ship's Name	Surveyor	Survey Date	
Thermography detailed exception report	Severity	Exceeds Fault Condition	
Location	Bridge Control Console	Fault Description	Localised Internal Heating
Equipment	Section 8	Fault Location	MCB 45Q2 - Main Body
Thermal Image		Digital Image	
Recorded Ambient: 22°C Recorded Reference: 37°C Recorded Anomaly: 78.7°C Recommendations: As a precaution please schedule to replace the MCB due to the increase in temperature.		Observation Notes: An increase in the temperature of the MCB.	
Thermography detailed exception report	Severity	Exceeds Fault Condition	
Location	Engine Room	Fault Description	Overheating Transformer
Equipment	Air Compressor Control Panel	Fault Location	Control Power Transformer
Thermal Image		Digital Image	
Recorded Ambient: 24°C Recorded Reference: 37°C Recorded Anomaly: 106°C Recommendations: Please schedule to replace the transformer.		Observation Notes: The temperature of the transformer continues to increase evident on the left side coil.

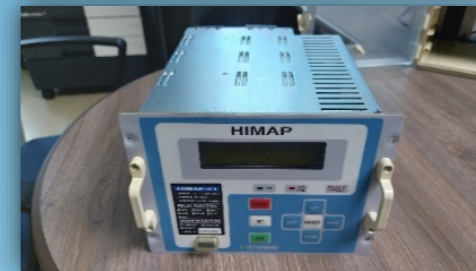
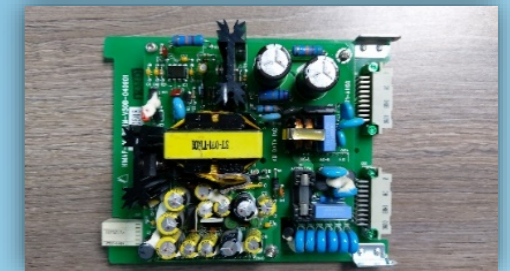
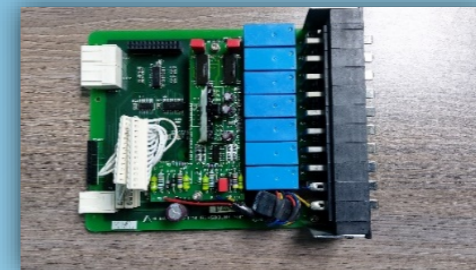
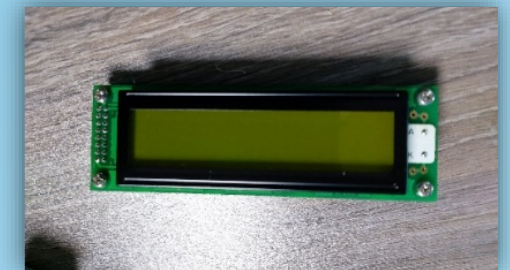
- HiMAP-M, T & FI: 6600V high voltage switchboard in Hyundai built LNG/C
- Customers Demands: High requests for repairing of HiMAP-M, T & FI and spare supply
- KGS service team: Rich service experience for HiMAP with competitive price
- SYMAP-BC/BCG complete: KGS provides SYMAP-BC/BCG as competitive price

- Spare Card List (HiMAP-M,T & FI)
 - Power Supply Unit: PWRM PCB (USD 550~)
 - Display Unit: VDF PCB (USD 200~)
 - Communication Card: CPM514 PCB
 - Main Board: RICM PCB Card & RPM PCB Card
 - Red Mark: Major spares requested by customers
 - Lead Time: 4~5 weeks

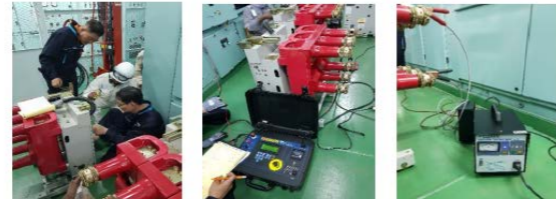
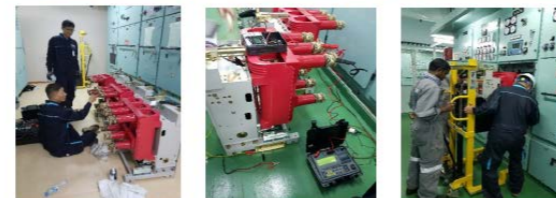
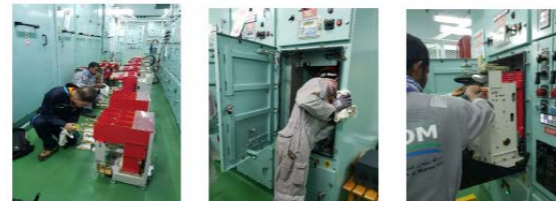
1.VCB & Vacuum Contactor inspection and test: 43 ea. (Refer to the attached report for more information).

1. Visual inspection and cleaning
2. Mechanical & electrical operation check.
3. Measurement of main contact resistance.
4. Insulation resistance test.
5. Vacuum Interrupter test.
6. Greasing for main contact.
