Generator Maintenance for LNG/C

Maintenance Report of DYNA GAS No.1

Customer : DYNA Gas
 Project : DYNA Gas / H2566
 Document : Generator Inspection
 File : DD Maintenance Report

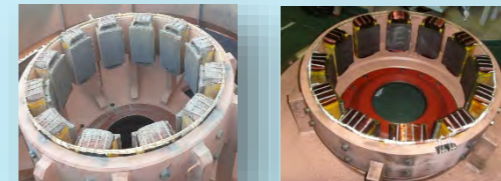
3) Replace exciter pole winding

Oil mist & dust will stack on surface of the windings. This will cause winding damage by low insulation.

Dismantle bearing, end shield and chemical cleaning. Replace the exciter pole windings
